## Molten salt baths cited as lab hazards

1982: Berkeley lab was demolished when a heated nitrite/thiocyanate mixture exploded

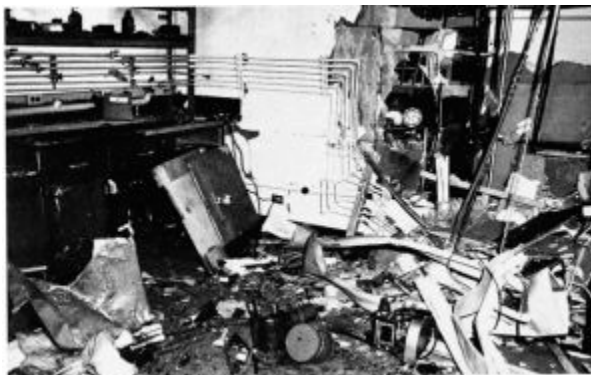
The explosion involved a glass polymer-synthesis apparatus immersed in a fused salt bath containing 3 lb of sodium nitrite and 1 lb of potassium thiocyanate. The bath had been heated above 270 °C using a hot plate. The experiment was being conducted in a closed fume hood.

The explosion, which Berkeley faculty members estimate had the force of about 1 lb of dynamite, caused more than \$200,000 damage to the new lab. The doors of the fume hood were imbedded in a wall 20 feet from the point of explosion and the interior walls of the lab were bulged outward. The chemical engineering graduate student conducting the experiment escaped probable death only because he was bending over to work on a floor vacuum pump at the time of the explosion.

King points out that, in the commercial mixtures, all of the components are oxidizers. In the mixture that exploded at Berkeley, thiocyanate, a reducer, was included and seems to have triggered the explosion. Mixtures that contain only nitrate and thiocyanate do not seem to explode. The explosive reaction involved nitrite and thiocyanate.
